INVENTORY INSPECTION REPORT

HOPKINTON LAKE SERVICE BRIDGE HOPKINTON LAKE CONTOOCOOK, NEW HAMPSHIRE *2*

August 1997

HOPKINTON LAKE SERVICE BRIDGE INVENTORY INSPECTION REPORT

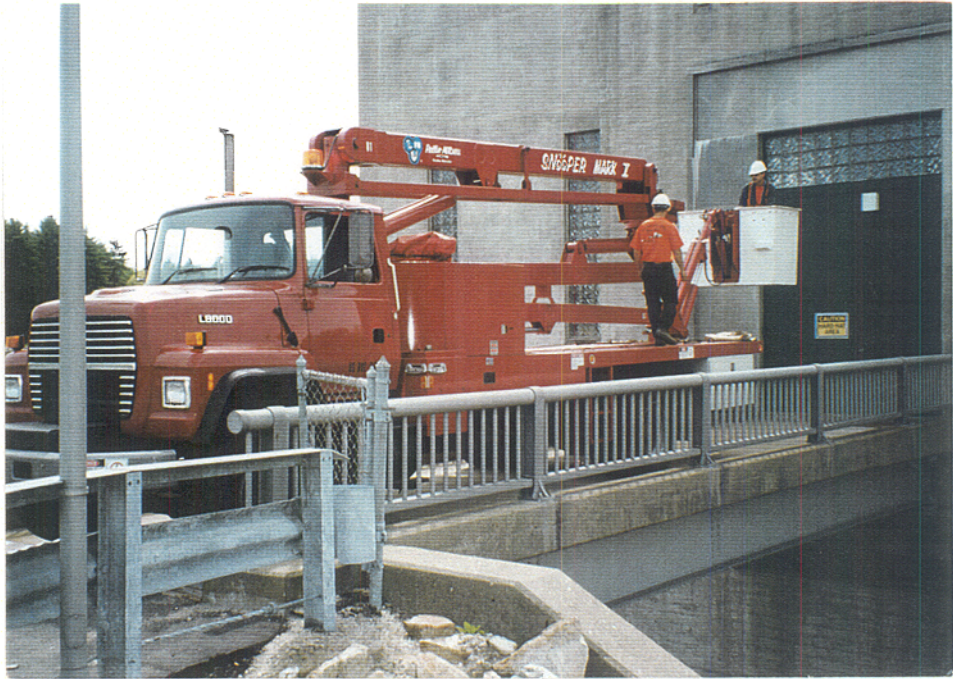
The bridge is 45 feet long and is a single span. It is a composite structure with two plate girders supporting a reinforced concrete deck (photo 1). The bridge is oriented approximately 90° from the approach road at the crest of the dam. The bridge roadway is 12'-0" wide between 1'-1" wide by 10" high curbs. Both curbs support aluminum post and pipe guard rails. The concrete deck varies in thickness from 8" at the curbs to 9" at the centerline. The plate girders are 36" deep

Photo 1: Hopkinton Service Bridge (View Looking Southeast)

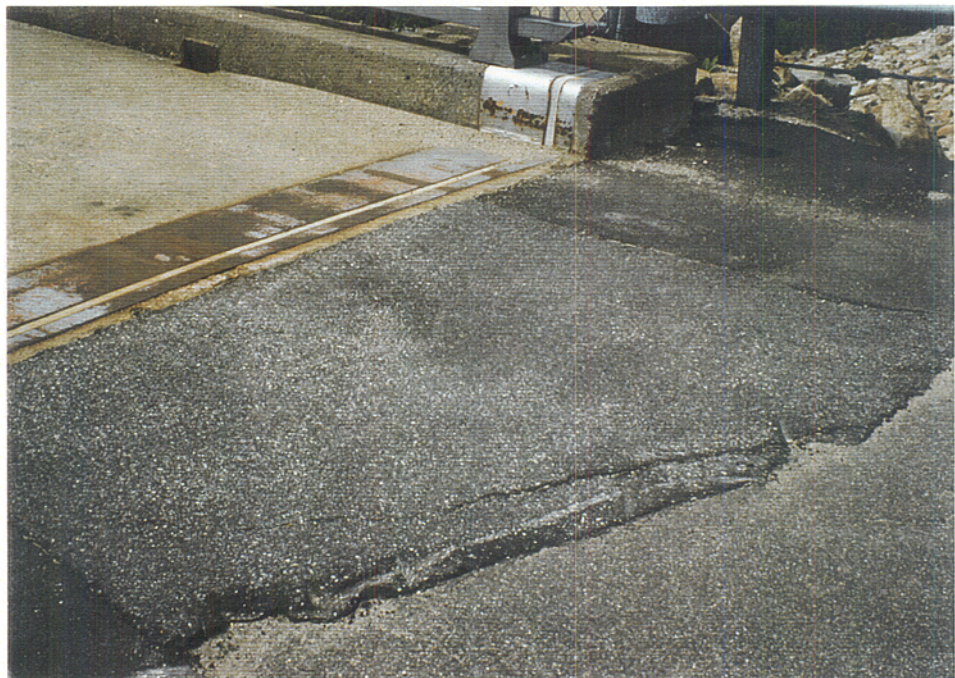
1. **APPROACH ROADWAY:** The bituminous approach roadway runs along the crest of the dam and is in good condition. There is a 90° turn from the two-lane approach road to the bridge deck. The bituminous pavement at the approach to the deck has settled (photo 2). The guardrail system along the approach is in good condition (photo 3).

Photo 2: Settlement at the Bituminous/Deck Interface

5. **RECOMMENDATIONS:** Repatch the spall at the concrete haunch at the control tower and replace the damaged bridge deck guardrail. Smooth the transition between the concrete bridge deck and the bituminous approach.

5. TRAFFIC SAFETY FEATURES: The bridge is not open to the public, and only carries maintenance vehicles out to the crest of the dam. The bridge guardrail system is in good condition. The bituminous pavement on the approach should be leveled to create a smooth transition for traffic.

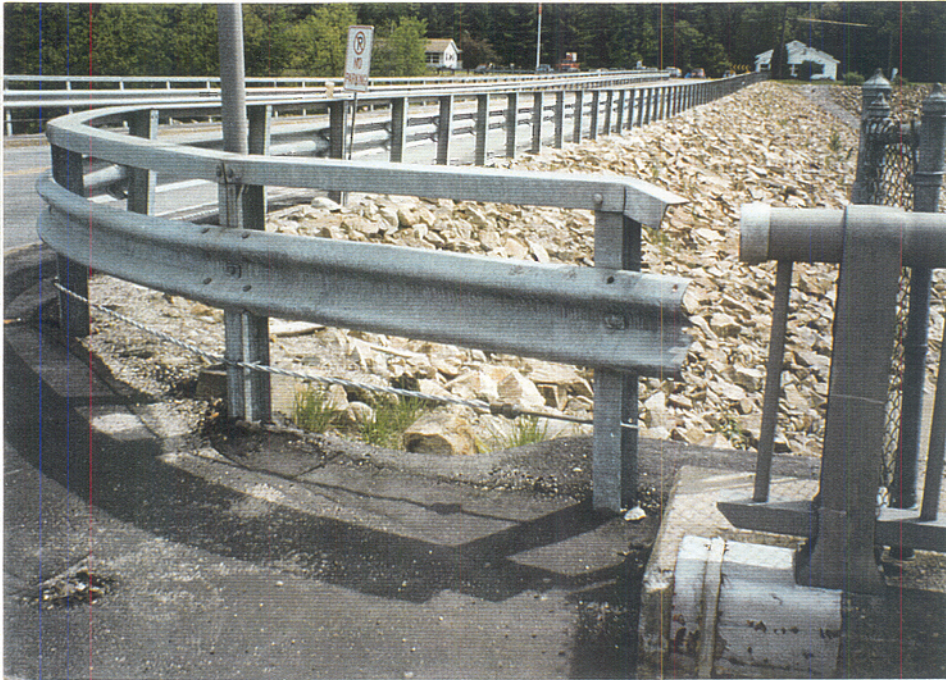
Photo 3: Guardrail System Along the Bridge Approach (View looking Northeast)

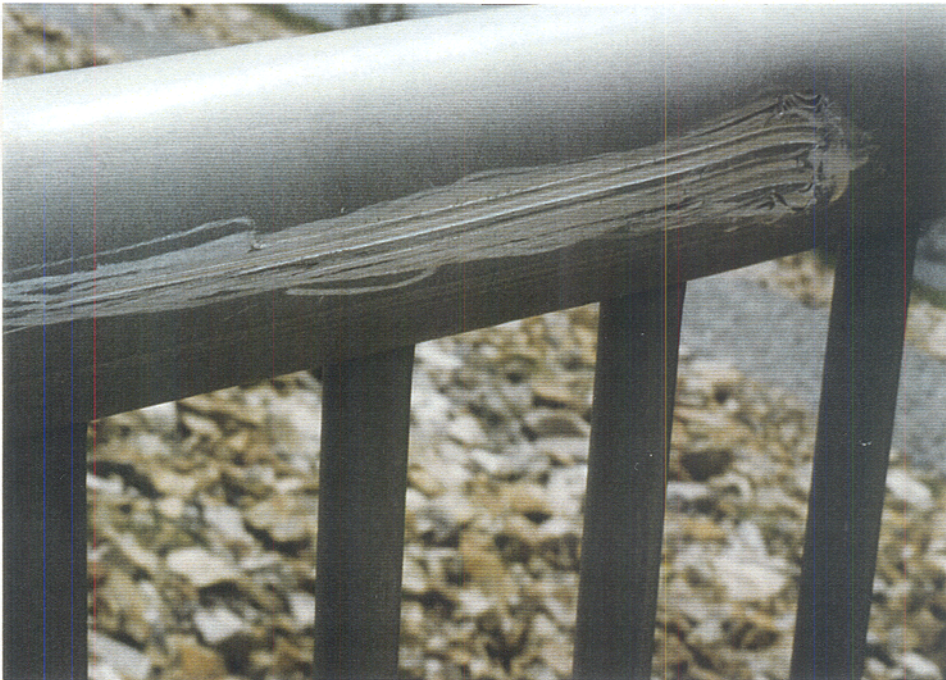
2. **DECK:** The deck is in good condition. The concrete surface shows minor wear and abrasion, and there are no cracks observed at the top surface or underside. The curbs and drains are in very good condition but the top eastside aluminum rail has a minor dent (photo 4). Utility conduits, which run the length of the deck along the exterior edges of the east and west girders, are in good condition but there is oil and grease on the utility conduits at the abutment (photo 5).

Photo 4: Minor Dent at the East Bridge Deck Guardrail

2. RECOMMENDATIONS: Repairing the minor concrete spall at the east haunch of the control tower and replacing the dented bridge guard railing should be included in the next concrete or bridge contract at the project.

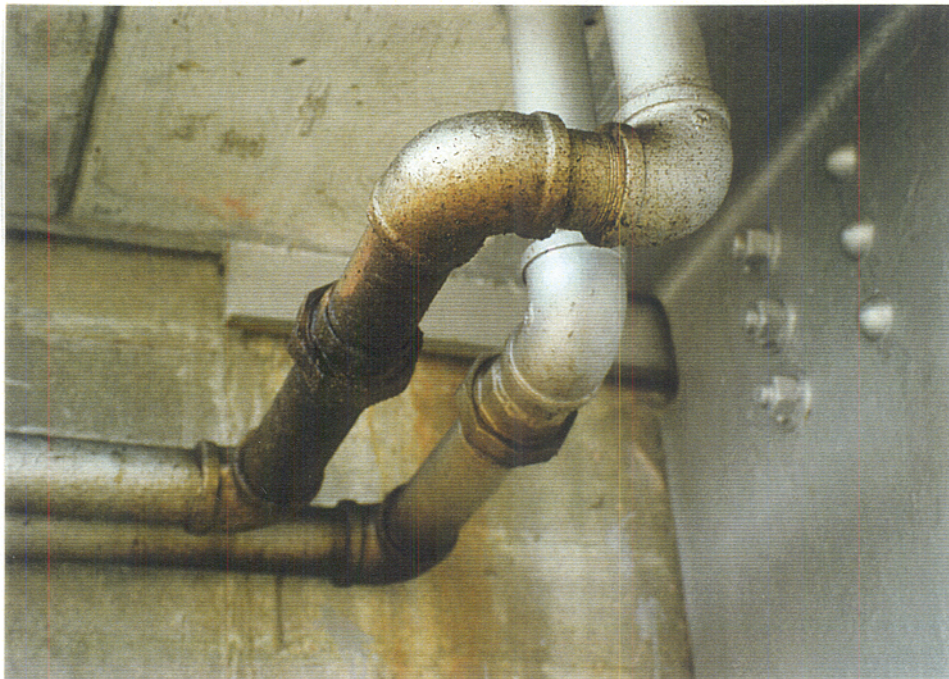
Photo 5: Oil and Grease on Utility Conduits at the Abutment

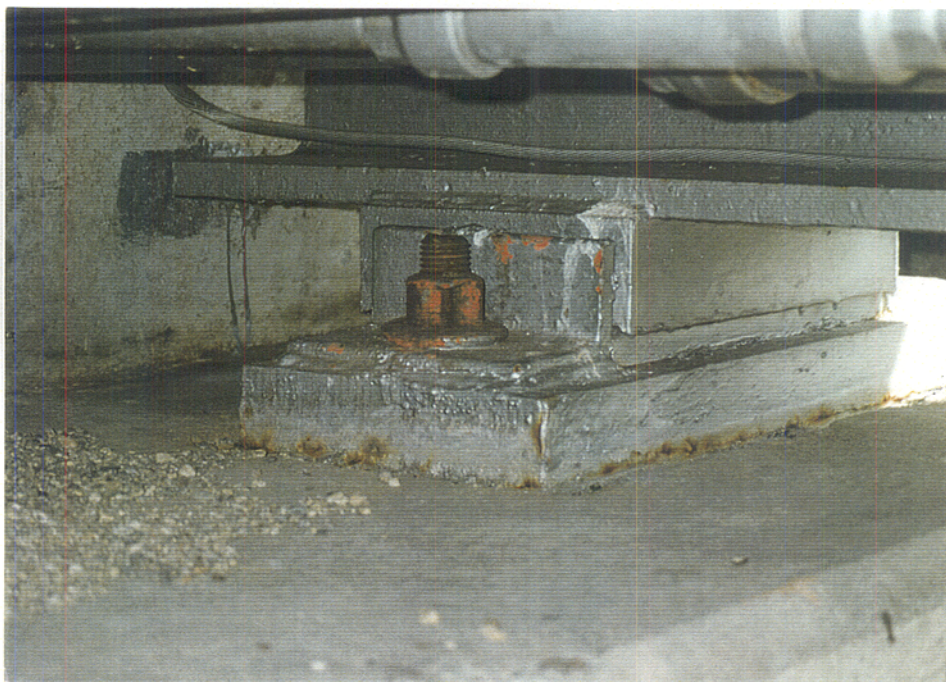
3. **SUPERSTRUCTURE:** The expansion (located at the north, abutment end) and fixed (located at the south, control tower end) bearings are in good condition with minor corrosion (photo 6). The clearance between the abutment back walls and the steel girders is as follows:

The condition of the girders and diaphragms is very good. There is very little corrosion on webs, flanges, and diaphragms and minor rusting of bearing plates and bolts (photo 6)

Photo 6: Minor Rusting of the Steel Bearing Plates and Bolts
At the North Abutment

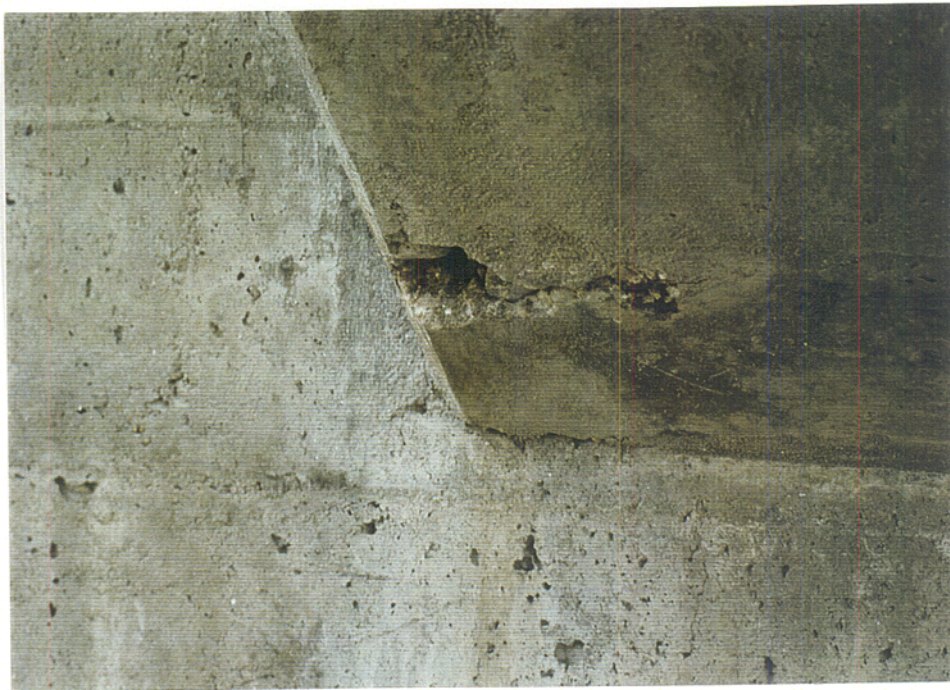
4. SUBSTRUCTURE: The southern abutment is in good condition with a minor spall at the eastern intersection of the back wall and the reinforced concrete haunch (photo 7). Rusty spots are evident along the steel plates against the concrete backwall walls at north abutment (photo 8).

Photo 7: Spall at the Reinforced Concrete Haunch.

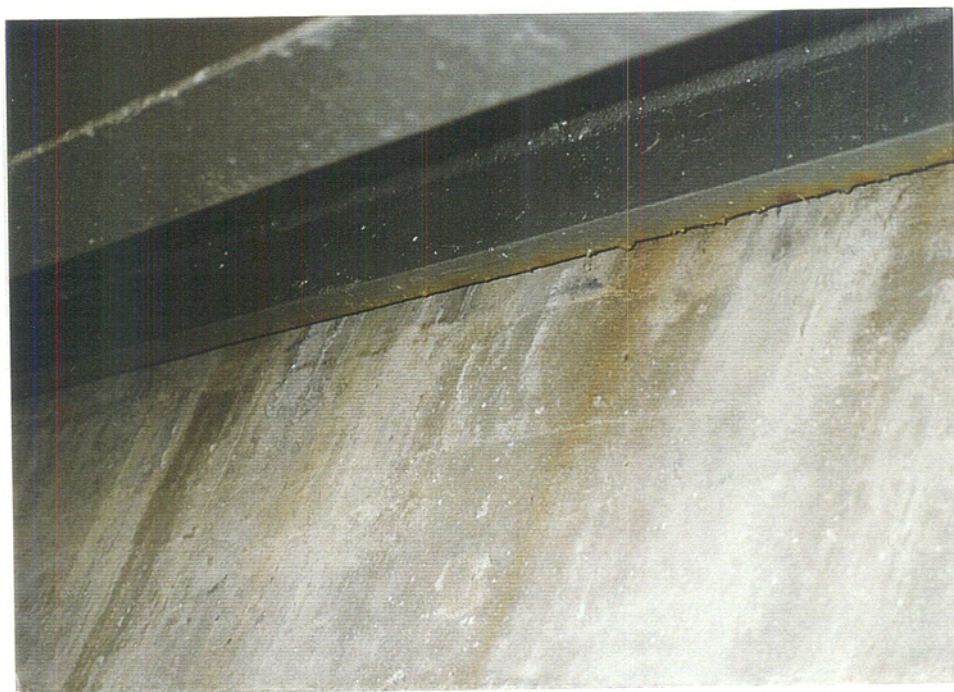
Photo 8: Rusty Spots At the North Abutment Concrete Backwall
